AMMRC-TR-78-27

INFLUENCE OF TEMPERATURE ON
HIGH CYCLE FATIGUE PROPERTIES
OF Ti-6Al-2Sn-4Zr-6Mo.

June 1978

ARMY MATERIALS AND MECHANICS RESEARCH CENTER
Watertown, Massachusetts 02172

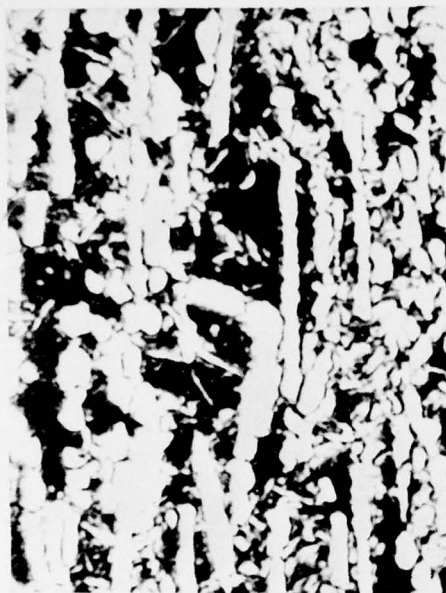
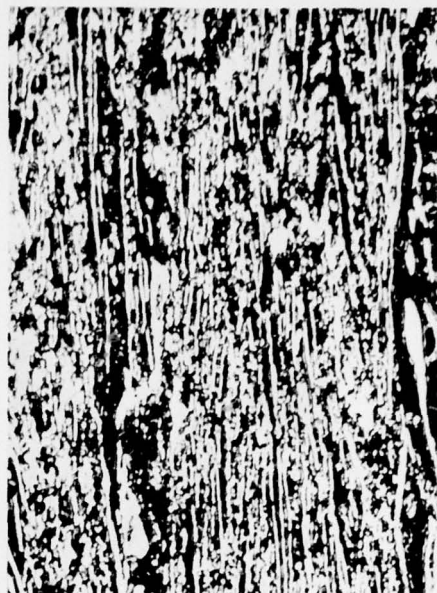
a. Ti-6Al-2Sn-4Zr-6Mo, as-received, sectioned parallel to rod axis.

Figure 5. Microstructure of Ti-6Al-2Sn-4Zr-6Mo. Etchant, 5 ml HCl, 500 ml H₂O, 10 ml Zefferin chloride, 1 ml HF.

The required microstructure for the alloy Ti-6Al-2Sn-4Zr-6Mo which results in an optimum combination of both fracture toughness and tensile ductility at yield strengths of 170 to 180 ksi has been identified.⁶ Such a structure contains primarily a matrix of coarse acicular alpha and aged beta.⁶ When the alpha particles are irregular in shape and somewhat elongated, a crack propagating in any plane not parallel to the axial face will find a more difficult path offered than when the microstructure consists of more equiaxed alpha. The microstructure of the longitudinal section in Figure 5 consists of a mixture of various sized rods and plates of alpha elongated in the direction of rolling (bar axis). Many titanium alloys are placed in service in the annealed condition. The annealing of titanium alloys serves primarily to provide adequate toughness and maximum ductility at room temperature and dimensional and structural stability at elevated temperatures. The material, therefore, was tested in the as-received annealed condition and the microstructure, consisting of elongated alpha particles in the rolling direction and perpendicular to direction of a propagating crack, offers resistance to fatigue crack propagation.

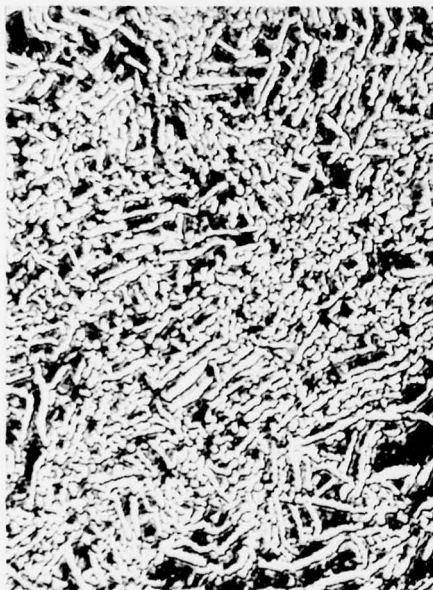
b. Ti-6Al-2Sn-4Zr-6Mo, as-received, sectioned transverse to rod axis.

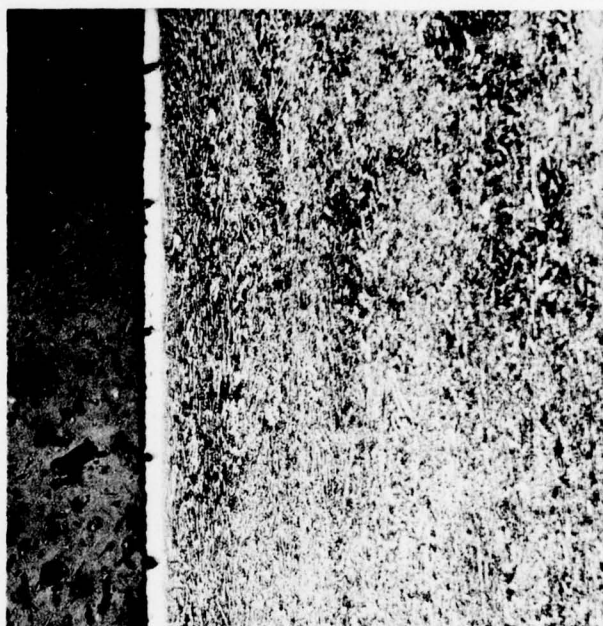
Figure 8. Ti-6Al-2Sn-4Zr-6Mo, coated with diffusion-bonded electroless nickel tested at 1000 F, 45 ksi stress, life of 5.8×10^6 cycles.

microstructural changes for 900 F and 1000 F are shown in Figures 3a and 6 and consist of refined alpha in a beta matrix. Photographs of the coated specimens tested at 1000 F (Figure 4) do not indicate an unusual influence of the coating on the refinement of the microstructure compared to uncoated specimens as would be expected. Grain refinement appears to offer an improved path for a propagating crack.
